Sales & Technical Bulletins

TRILLIUM Valves USA™

Trillium - Table of Contents

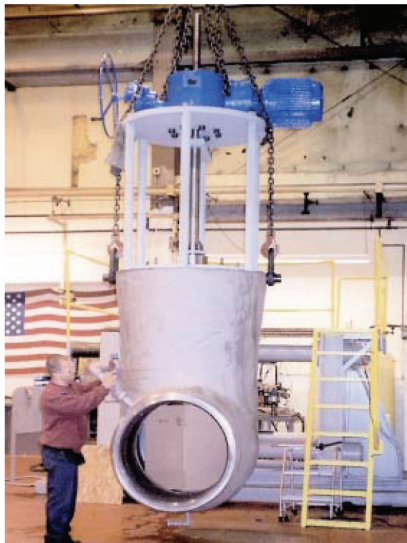
36” Class 705 SPL INT Parallel
Slide Gate Valve WT – 25,300 lbs.
15 ½ Ft. Tall

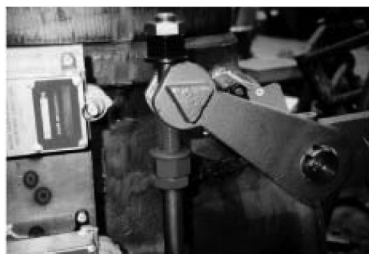
A valve which has been improperly setup can quickly be spotted by looking at the Inspection lever arm adjustment nuts. Wide Gaps between the flange nut faces and lever arm indicate that the valve may not function as designed. The valve needs to be reset as soon as possible.

Incorrect Setup:
more than 1/8” between bottom Flange Nut Face and Lower Arm.

The valve will require adjustment during the next available shutdown if these conditions are

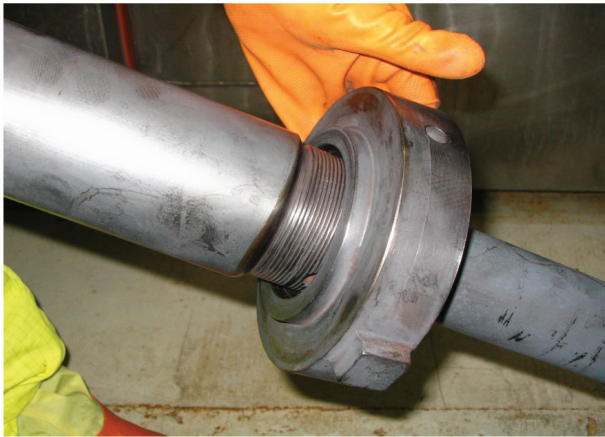
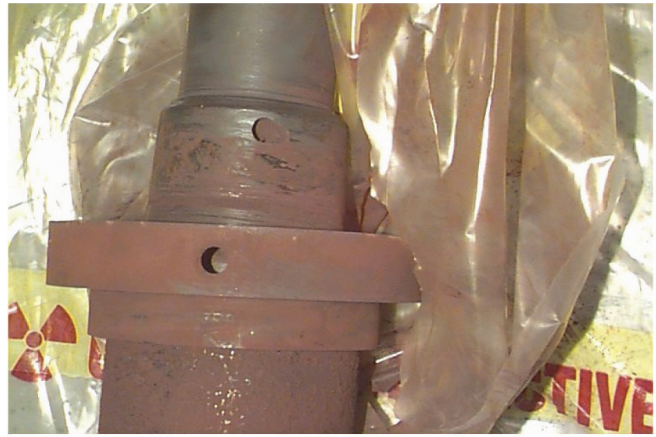
PROBLEM The three piece MSIV stem has been an issue since the original design of the MSIV. The original design incorporated a stem with a threaded on top spring seat with tack welds at the interface of the two parts. When it was discovered that the tack weld cracked, a dowel pin and then a taper pin was used to lock the two parts together. These too have failed with the result of the top spring holder coming loose and loosening the solid connection between the poppet and stem. The two pictures below illustrate the results of the parts separating.

This is not a safety issue as the valve will still close and seat tightly, but it does allow for accelerated internal wear.

SOLUTION The solution to the problem was to manufacture the stem from a one piece forging. This eliminated the screwed and peened connection, which completely eliminates the possibility of the spring holder loosening. This redesign also incorporates the anti-rotation lugs as part of the forging, which also eliminates the past practice of welding them on the edge of the spring holder.

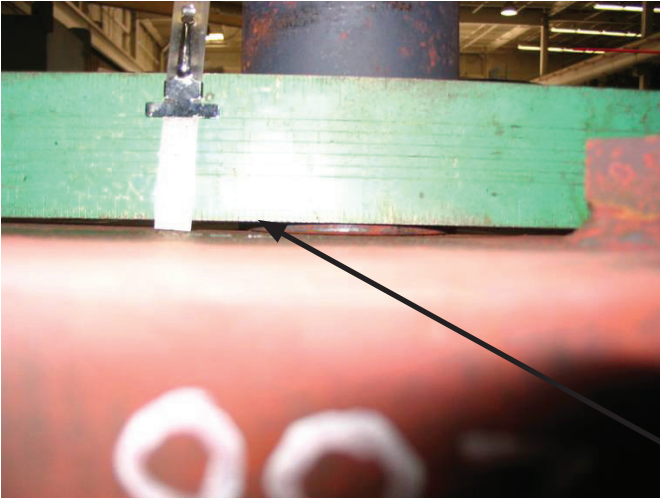
Illustration A

Illustrates a disc that has dished out from damage resulting from cumulative severe closures.

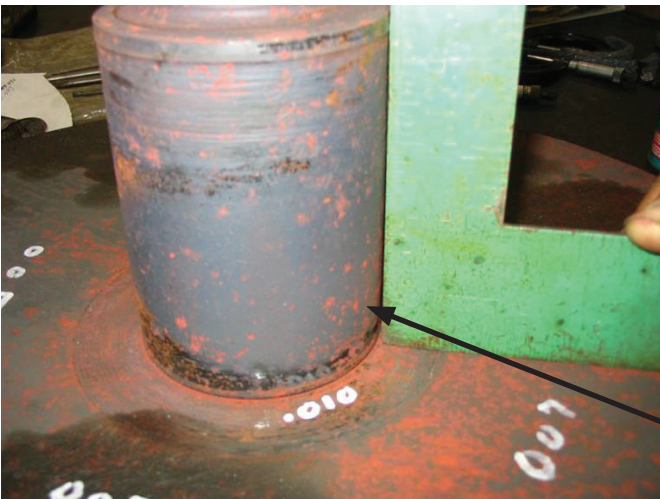
Illustration B

Illustrates a disc post that is bent out of position from damage resulting from cumulative severe closures.

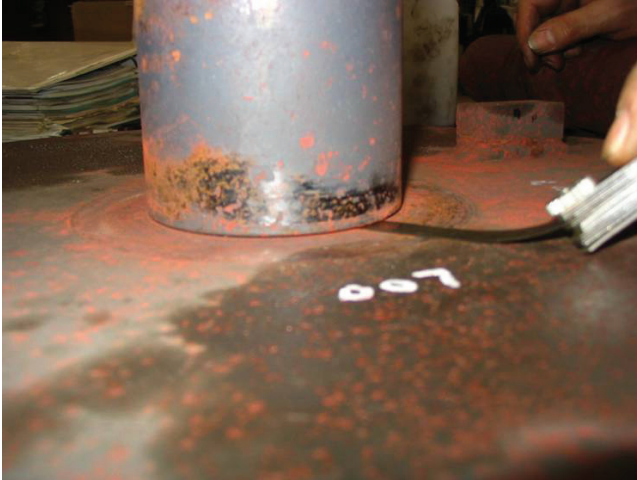
Illustration C

Disc post has lifted off the disc plate due to damage resulting from cumulative severe closures.

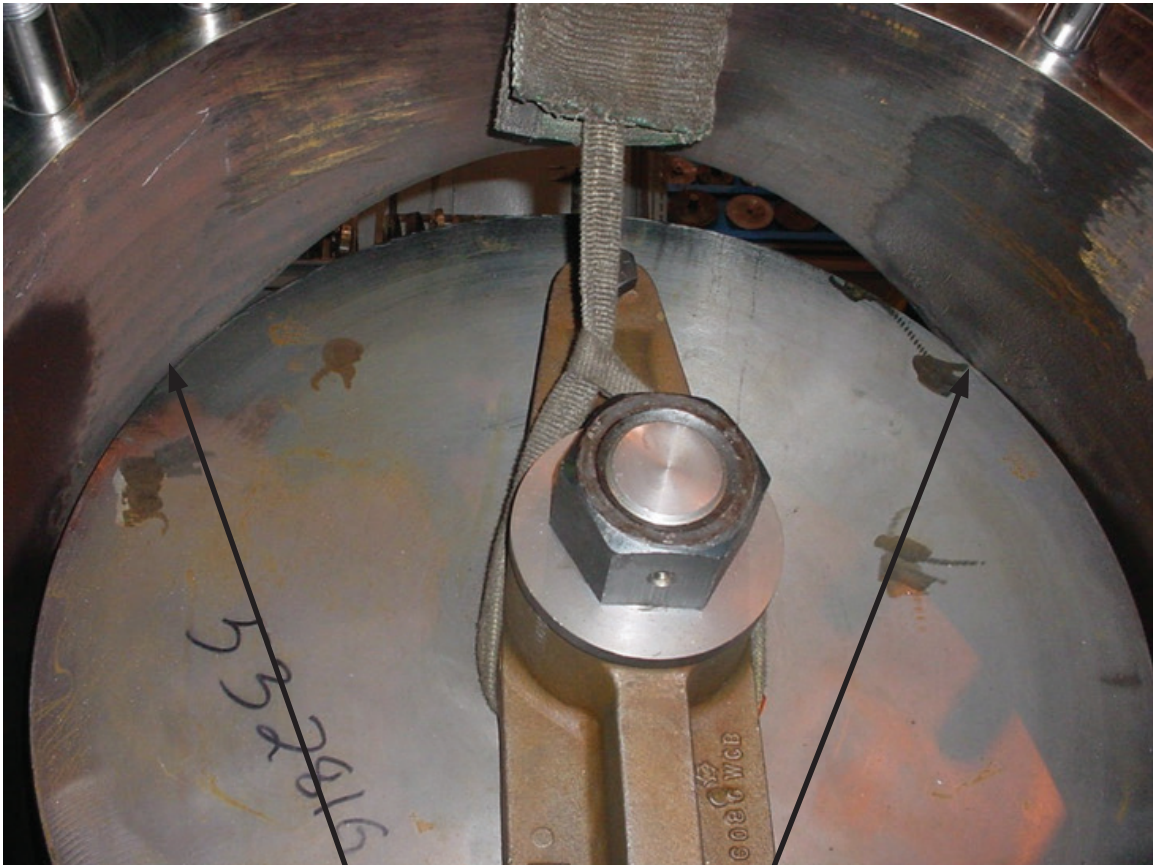
Illustration E

Areas shown above must not be in contact with valve body. A minimum of 1/8" should be maintained between body and disc.

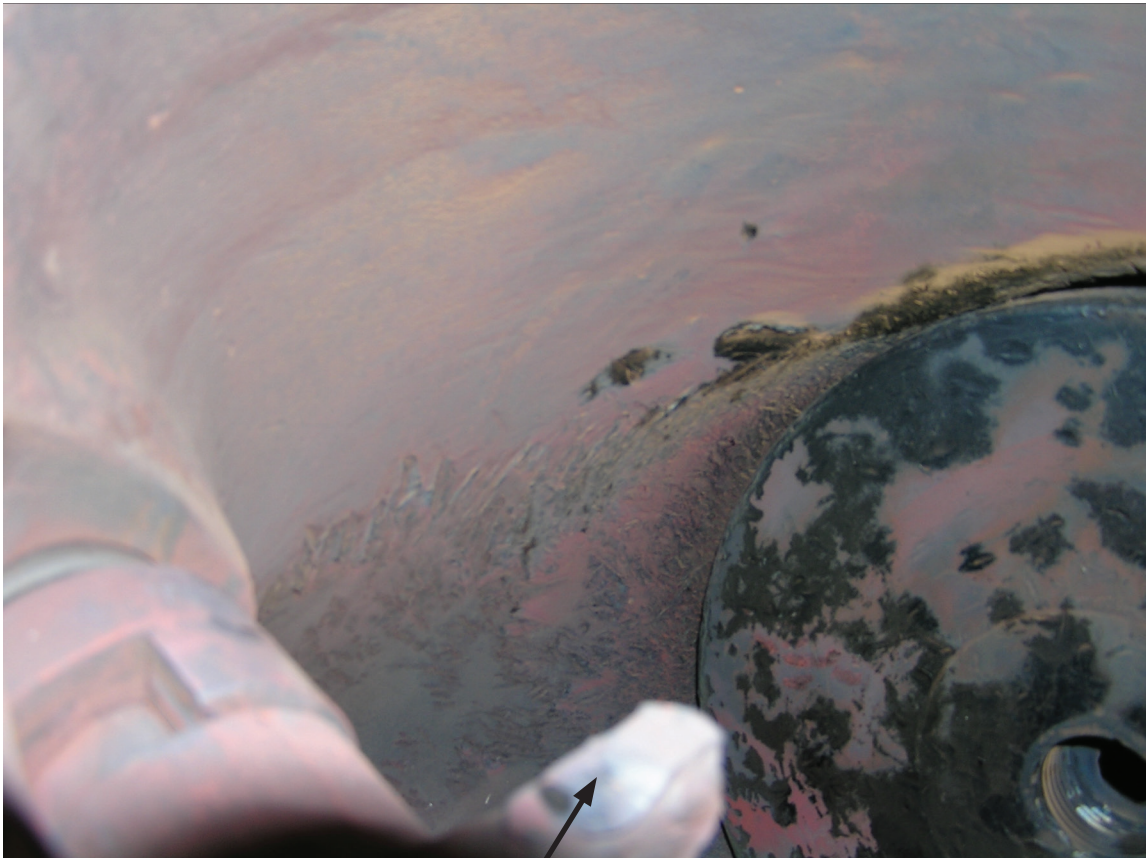
Illustration G

Illustration of disc stop worn beyond acceptable smooth transition to prevent over travel and body to disc contact.

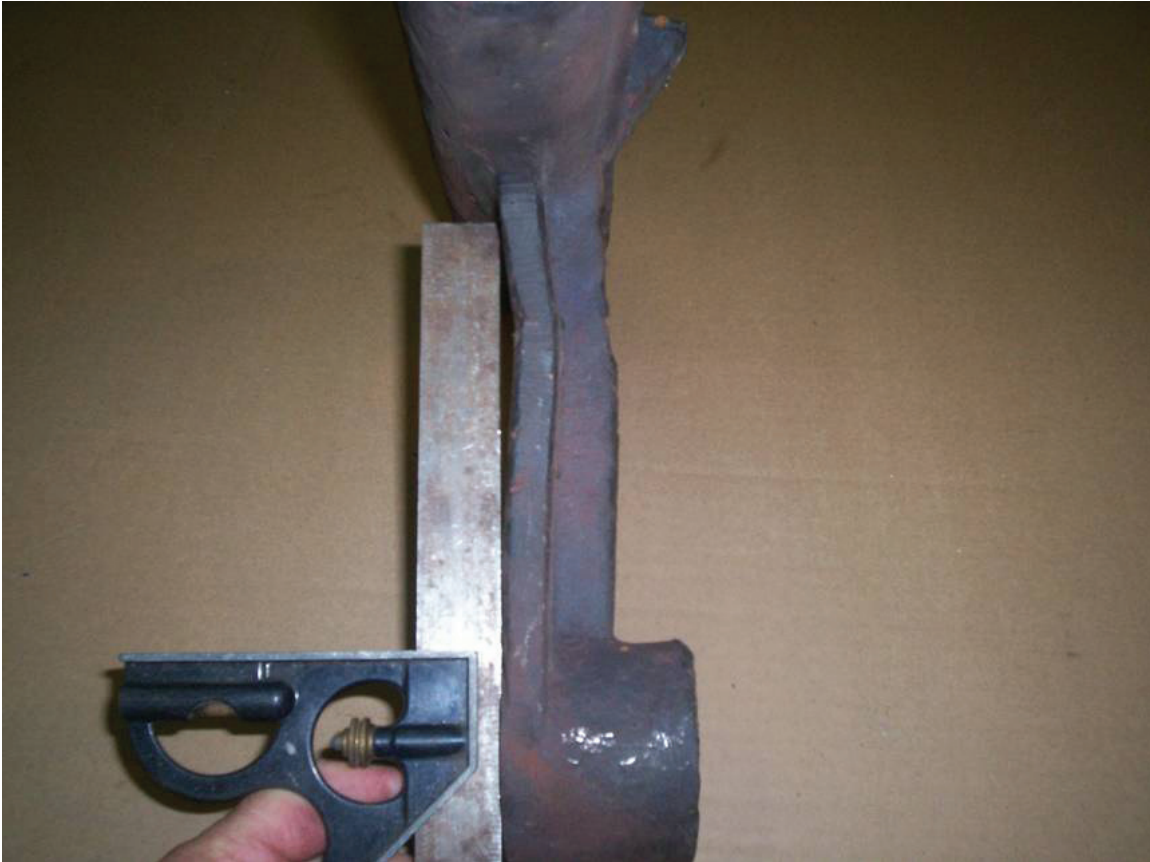
Illustration H

Illustrates a disc arm that is bent out of position from damage resulting from cumulative severe closures.

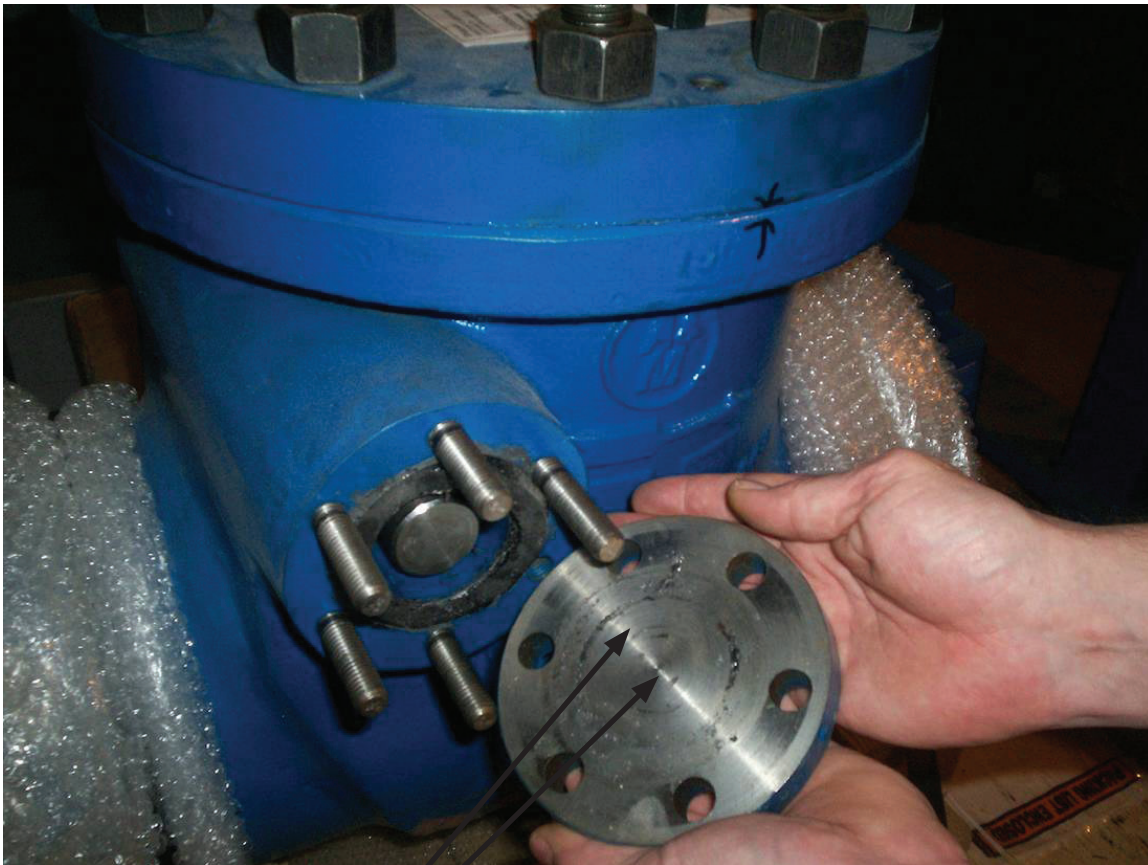
Illustration I

This cover should not have a spacer welded on it or between the bearing cover and shaft. A gap of a 1/32" minimum clearance between the cover and shaft must be present. This clearance is measured with the shaft pulled as far to the opposite side of the valve from this cover surface. Failure to have this clearance could result in thermal lock up of the shaft to bearing cover, keeping the valve from closing.

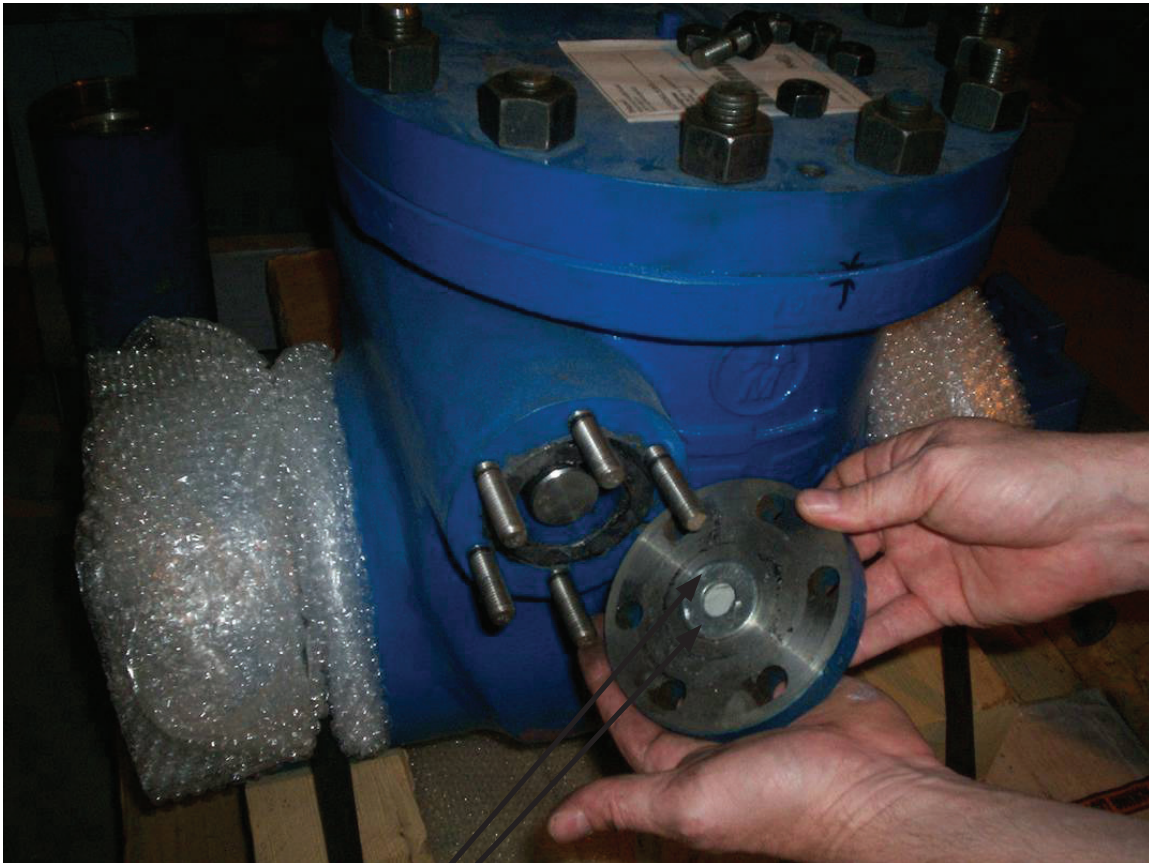
Illustration J

This represents the washers or spacers we have seen at various sites. These have been added in an effort to center the disc assembly. Personnel add these as they notice that the shaft is moved towards the bearing cover while installing the packing. Spacers and washers should never be added. The shaft will shift back when pressure is established in the valve causing a pee shooter effect on the shaft.

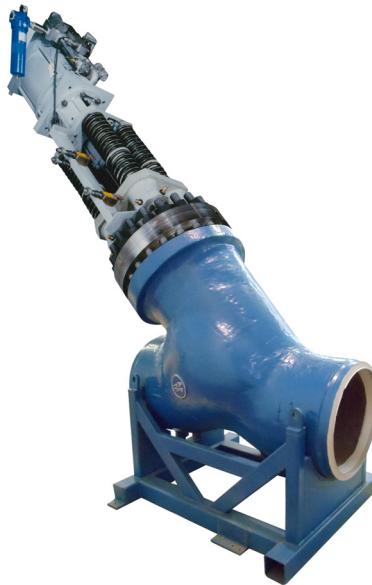
There have been three recent, related MSIV stem failures; one in France, one in Slovenia and one at Plant Vogtle in the US. The failure at Plant Vogtle was not a Trillium design and is not a Wye Globe Valve. (That particular MSIV was a Wedge Type Gate Valve. The design and operating parameters associated with that failure are very different from Wye Globes.) For example, the tensile and shear loads are significantly greater on Wedge versus Wye Globe Valve designs.

The failure in France was on a Wye Globe MSIV that was manufactured by Delas (in France). This design differs from the Trillium design in the method of stabilizing the poppet. Trillium's current design includes 360° support of the poppet, providing greater surface contact area. Flatness can be confirmed by verifying total indicated run-out. The Delas method of stabilizing the poppet utilized three posts attached to the top of the poppet. If there is any wear on any one of the posts, the poppet will be side loaded which would put added stresses on one side of the stem. The intent of the Trillium design (poppet modification) is to eliminate poppet movement, vibration and the resultant cyclic fatigue (failure root cause).

The failure in Slovenia was a non-stabilized Wye Globe Valve, which was a Trillium designed and manufactured valve (manufactured prior to the poppet stabilization design modification). The failure of that stem was directly related to the valve not having a stabilized poppet assembly, allowing for fluid born vibration with secondary effects that may have occurred as a function of thermal embrittlement of the ASME SA-564 Gr. 630 H1100 stem.
